Beautiful, stately HISTORIC HOMES

by MARIE SOPROVICH

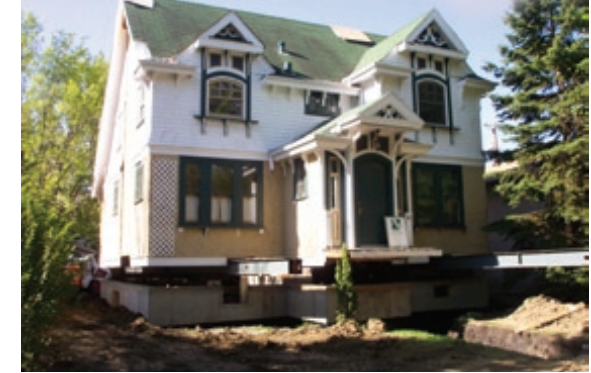
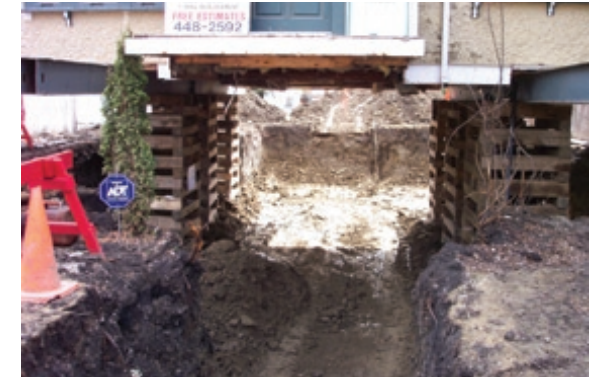
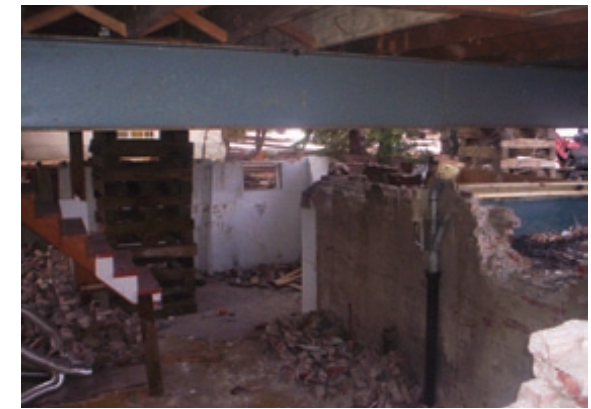
THE HOUSE WAS SECURED WITH BEAMS AND HYDRAULIC JACKS INCHED UP THE ENTIRE HOUSE WHILE WOODEN PILES WERE USED TO SHIMMY AND SECURE THE HOUSE HIGH OFF THE GROUND. ONCE THE HOUSE WAS HIGH ENOUGH THAT A BOBCAT COULD GET UNDERNEATH THE OLD FOUNDATION WAS REMOVED AND THE NEW BASEMENT DUG CAREFULLY, CRIBBED AND THE NEW CONCRETE FOUNDATION WAS POURED.

Steel girders were placed under the house and supported by "house of cards" pillars of pressure treated lumber. After the connection between the house and basement was broken, hydraulic jacks placed under the girders inched up the house. Brave workmen stood under the house, placing more lumber beams on the growing pillars. Once the house was high enough, a bobcat manoeuvred underneath to remove the remaining foundation and to dig out the new 9 foot ceilinged basement—a great improvement over the low and gloomy original. The new foundation walls were cribbed and concrete poured. After the concrete was cured, the house was gently set back down on its new foundation. "It was tricky, but it worked" recalls the site supervisor. Not only was the new foundation higher, but the whole house was nudged over two feet to become compliant with new zoning laws. With the house firmly in place, the renovation was back on familiar territory for the Aquarian team.
